EVALUATION OF HYDRAULIC INFRASTRUCTURES IN THE HEADWATERS OF THE BARRA NOVA STREAM – APUCARANA, PR

Table 3. Hydraulic infrastructures evaluated in Barra Nova stream.

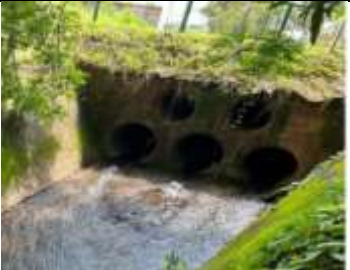
| Location | Stability Indicators | | | | | | | | | | | | | Total | Stability Status |
|---|---|---|---|---|---|---|---|---|---|---|---|---|---|---|---|
| 2 | 12 | 12 | 1 | 10 | 9 | 7 | 12 | 2 | 3 | 9 | 12 | 12 | 03 | 104 | Fair |

| Location 2 | | Concrete Quintuple Tubular Culvert |

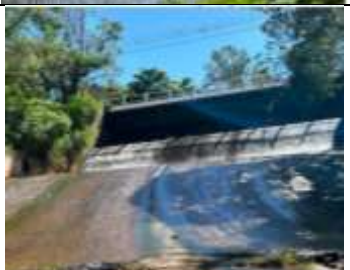
| Location | Stability Indicators | | | | | | | | | | | | | Total | Stability Status |
|---|---|---|---|---|---|---|---|---|---|---|---|---|---|---|---|
| 3 | 7 | 10 | 4 | 7 | 10 | 7 | 9 | 2 | 3 | 10 | 7 | 7 | 1 | 84 | Good |

| Location 3 | | Concrete Bridge (22m width) |
