## Urbanization Impacts on Water Bodies in the city of Apucarana-PR (Brazil)

CORREIA, C.N.\*, PRATES, K. V. M. C.\*\*, JABUR, A. S. and UEDA, A. C.

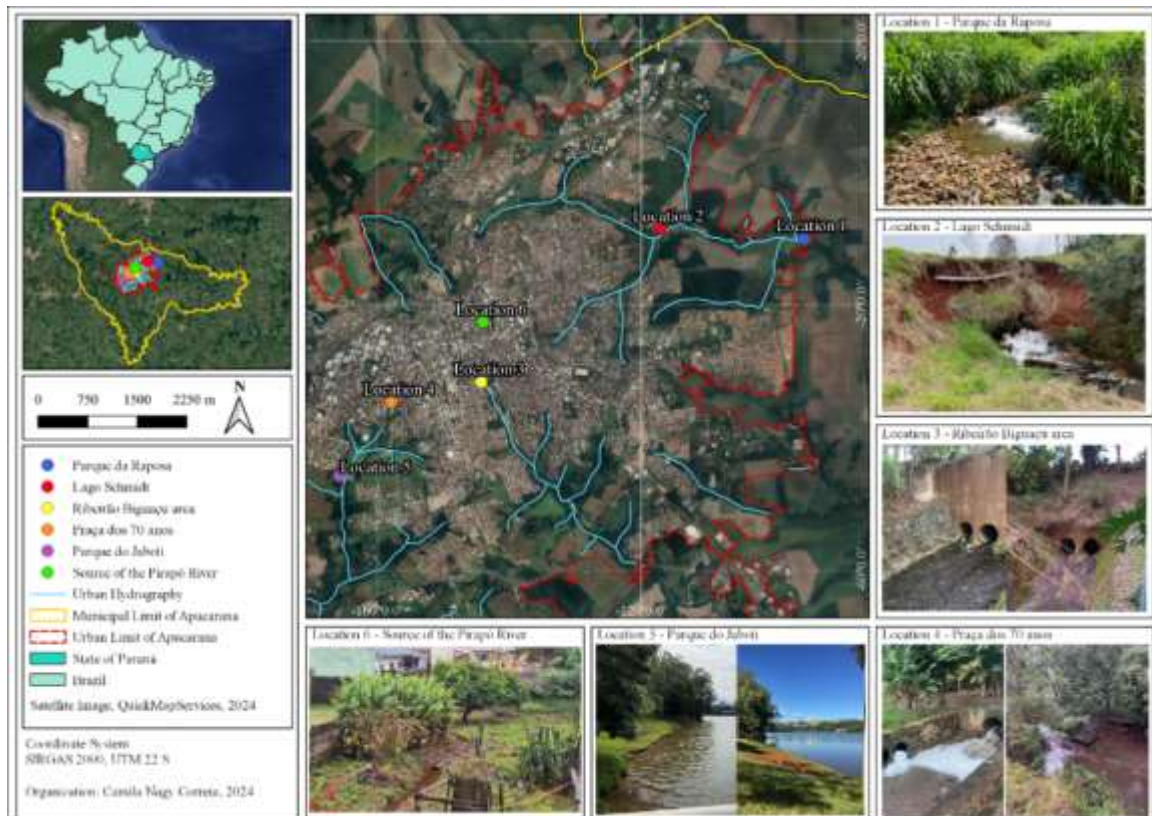
Figure 1. Study Locations and Photographic Records

To contextualize the analysis of urban impacts on water bodies, it is essential to understand the spatial distribution of the visited locations and the observed anthropogenic activities. Figure 1 shows the location of the visited points and the records of the anthropogenic actions found at these locations.

The *Parque da Raposa*, location 1, is a Conservation Unit with a dammed lake that requires ongoing maintenance to prevent bank siltation (SOBRINHO, NIGRO, 2014). Despite these efforts, siltation persists due to sediment transport from soil erosion, reducing the lake's depth and increasing flood risks. Previous studies highlight that unregulated urbanization and lack of riparian vegetation are key factors in siltation (WEN et al., 2021). Geospatial analysis confirms high urban pressure in the area, underscoring the need for interventions to address these issues.

At *Lago Schmidt*, location 2, various issues related to urban pressure were noted, including fluvial erosion, a dam in poor condition, and irregular occupation in the Permanent Preservation Area. The observed erosion aligns with studies showing that urban development exacerbates erosion, particularly where vegetation is removed for construction. Irregular occupation along the lake's margins is common in urban areas, where expansion often encroaches on sensitive environments (WEN et al., 2021). Field photographs confirm these issues and a review of land use policies highlights inadequate enforcement and lack of integrated water resource management in the region.

The *Ribeirão Biguaçu* area, location 3, is situated between two parks: *Parque São Francisco de Assis* and *Parque da Bíblia*. The anthropogenic intervention in the region is evidenced by the channelization of the stream, which was implemented to address the frequent erosion processes in the area around the 1970s (TORRES, 2014; FARIA, 2007; FERREIRA, 2006). Field observations revealed that the channelization led to altered hydrological patterns, including changes in runoff and sediment load, suggesting that despite the modifications, the channelization had a positive impact on mitigating erosion in the region.

The *Praça dos 70 Anos* area, location 4, emerged from a restoration project aimed at revitalizing the *Córrego Jaboti*. This area is situated within an urbanized zone, where anthropogenic activities have led to significant environmental changes. The lack of natural vegetation along the stream's banks, combined with urban infrastructure, has contributed to issues such as pollution and erosion (HALL & HOSSAIN, 2020). Field visits confirmed the presence of these impacts, highlighting the need for improved urban planning and sustainable practices.

The *Parque do Jaboti* area, location 5 features an artificial lake formed by the confluence of *Água da Lagoa*, *Jaboti*, and *Barra Nova* streams. Water quality here is compromised by fecal contamination and *Escherichia coli*, as shown in previous studies (SCHUBERT, MIKALOUSKI, 2019). Situated in an urban zone, the park's pollution aligns with urban lake assessments, where inadequate sewage systems and runoff contribute to contamination (WEN et al., 2021; TERNUS et al., 2011). Field observations indicate ongoing pollution, likely from domestic effluents and animals in the contributing streams.

The source of the Pirapó River, location 6, The source of the Pirapó River, location 6, is situated in an urban area and is not shown on official maps due to its underground flow. The lack of protective boundaries and the soil's low compaction allow rainwater infiltration (GRIZIO and CANEZIN, 2018). Geospatial analysis showed significant urban pressure at the site. The absence of protective vegetation and ongoing urbanization threaten the water quality and ecological integrity of the Rio Pirapó (CESSSEL et al., 2019). Field visits documented these issues, with photographs depicting the degradation of the spring area.

The analysis of various locations in Apucarana revealed the complex impacts of urbanization on the city's water bodies. Results emphasize the need for sustainable management and integrated urban planning. While some interventions have addressed specific issues, urban expansion still exerts significant pressure on water resources. Implementing policies that balance environmental preservation with urban development is crucial for protecting water quality and ecological integrity.
